AVIATION INVESTIGATION REPORT
A17F0052

Risk of collision with terrain

WestJet
Boeing 737-800, C-GWSV
Princess Juliana International Airport, Sint Maarten
07 March 2017

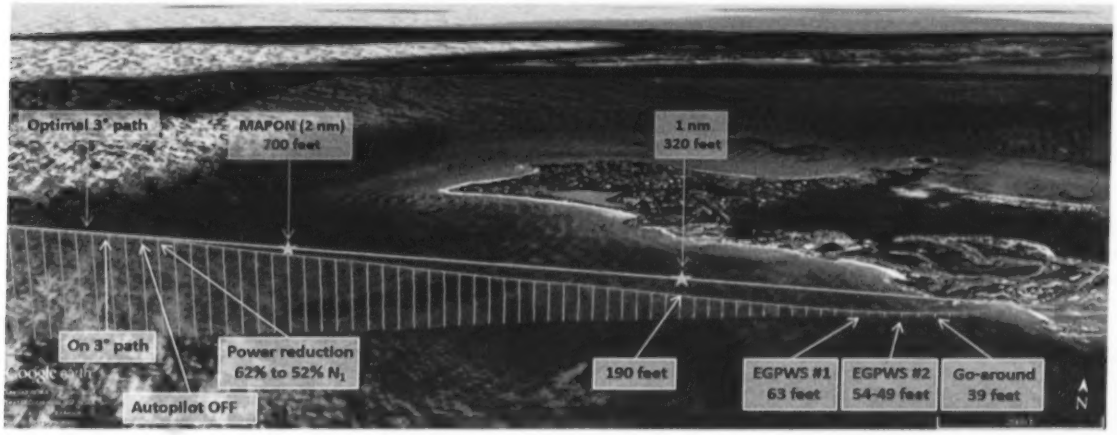
Figure 2. Standard 3° angle of descent versus the aircraft vertical approach path

An increase in visual workload led to inadequate altitude monitoring, which reduced the crew's situational awareness. As a result, the crew did not notice that the aircraft had descended below the normal 3° angle of descent to the runway threshold. The lack of visual texture and other visual cues available over water contributed to the crew's inability to detect the aircraft's reduced height above the water.

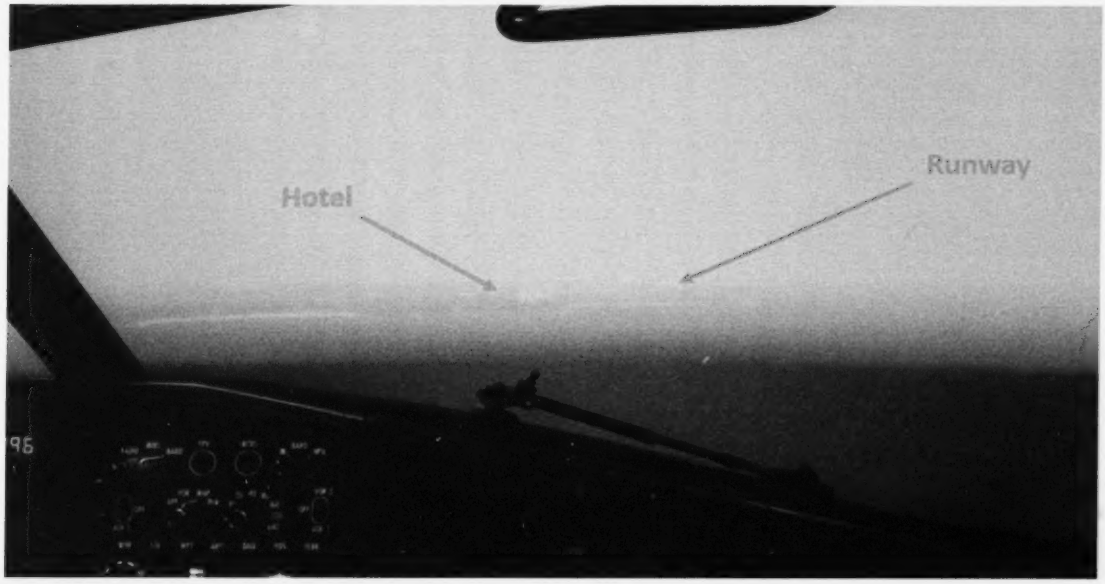
The simulator did not allow for an exact replication of all of the visual conditions at the time of the occurrence, such as the effect of the rain on the windshield. However, the exercise demonstrated a significant reduction in the visual discernibility of the runway environment when visibility diminished to 2000 m. It also highlighted the necessity for runway and PAPI lights to be illuminated at high intensity to clearly demarcate the runway edges under conditions of low visibility.

Figure 3. Visual references as seen in a flight simulator at approximately 500 feet AGL in poor visibility

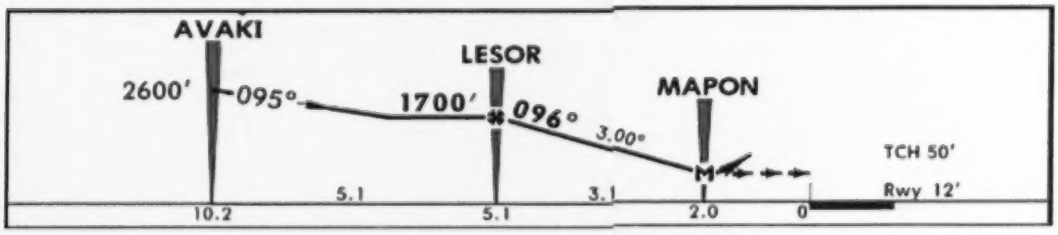
In this occurrence, the FMS provided the crew with vertical guidance to the MAP during the inbound final approach course. Because there is a mountain close to the runway, the MAP is situated 2 nm (3704 m) before the runway threshold, and the MDA is at 700 feet ASL (688 feet AGL), to meet the PANS-OPS[39] criteria for obstacle clearance in the event of a go-around. Therefore, there is a long visual flight segment following the MAP where the crew is required to manage the descent to the runway threshold in order to complete the landing (Figure 4). It is not common for WestJet pilots to fly long visual segments of an IFR approach such as that of the RNAV (GNSS) Rwy 10 at TNCM. Even less common are long visual segments over water and with the type of weather encountered during the occurrence approach.

Figure 4. Descent profile for the RNAV (GNSS) Rwy 10 approach to Princess Juliana International Airport (Source: Jeppesen Sanderson Inc., approach chart)

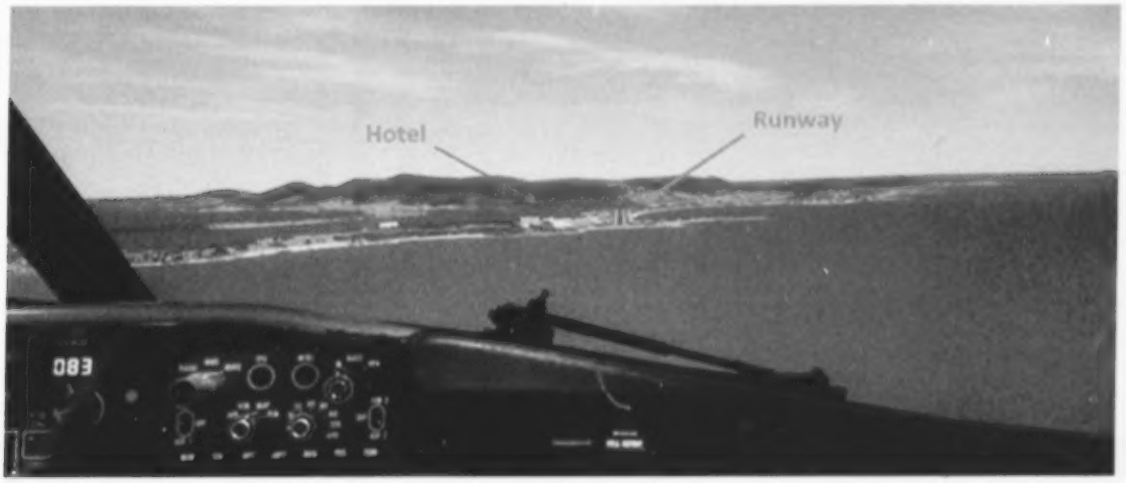
At TNCM, the RNAV (GNSS) Rwy 10 inbound final approach course is situated over ocean and includes a visual segment of 2 nm from the MAP to the threshold, which is adjacent to the shore (Figure 5). The visual references available for the RNAV (GNSS) Rwy 10 approach include

Figure 5. Approach to Runway 10 at TNCM on a clear day, viewed in a flight simulator
